DEVELOPMENT OF REPAIR PROCESSES
AND SOURCES FOR C/KC-135 AIRCRAFT
WINDOWS/WINDSHIELDS

BATTELLE
505 KING AVENUE
COLUMBUS, OH 43201

SEPTEMBER 1994

TECHNICAL REPORT FOR 09/91 - 01/94
C/KC-135 FINAL REPORT
CONTRACT NUMBER FO9603-90-D-2217-SD02

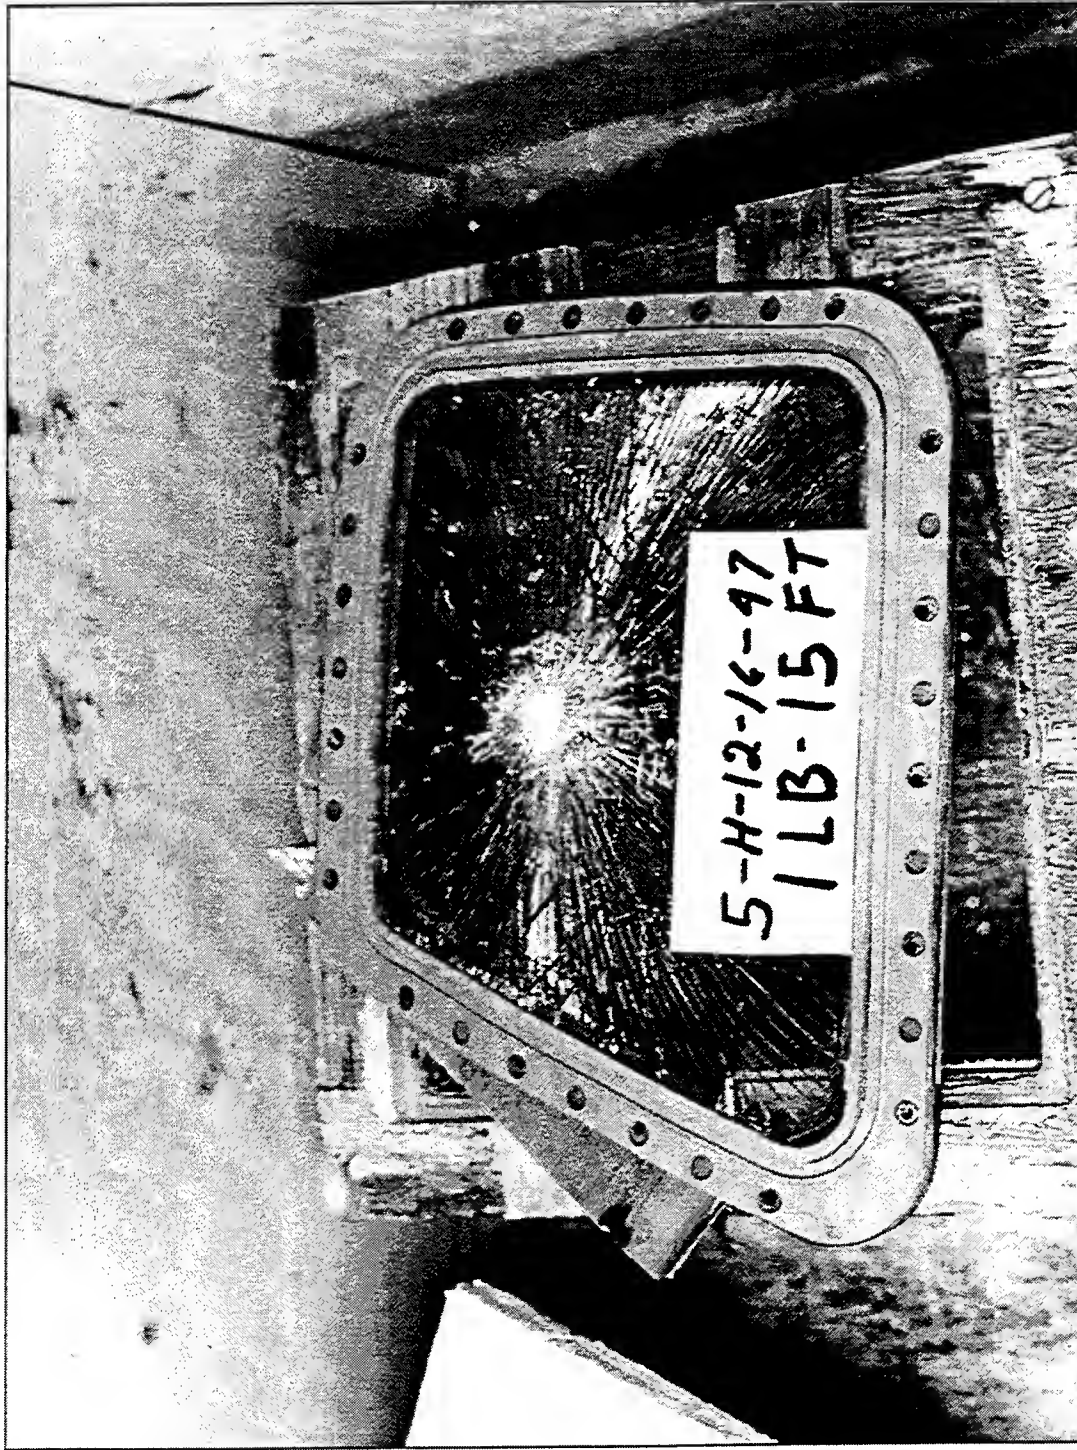
Figure 4.18 #4 W/WS Residual Strength Falling Ball Impact Test Result for a Repaired and Subsequently Delaminated W/WS, Outboard View
(S/N 5-H-12-16-47)

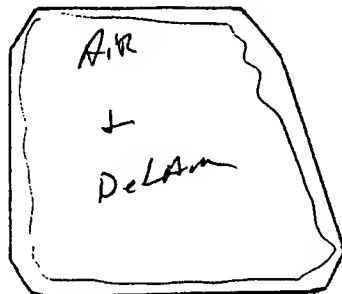
Visual Inspection Map & Comments

1: <u>.689</u> 2: <u>.701</u> 3: <u>.697</u> 4: <u>.687</u>			
Check for Vinyl Cracks:	<u>Acc</u>	<u>JUN 03 1993</u>	<u>22 PPG 77</u>
Seal Evaluation:	<u>ReS</u>	<u>JUN 03 1993</u>	<u>22 PPG 77</u>
(Comments)	<u>BAD Bumper at wing seal on out side</u>		
Visual Inspection: (Place comments on attached sheet)	<u>ReS</u>	<u>JUN 03 1993</u>	<u>22 PPG 77</u>

AIR And DeLAM is located ALL AROUND
Unit.

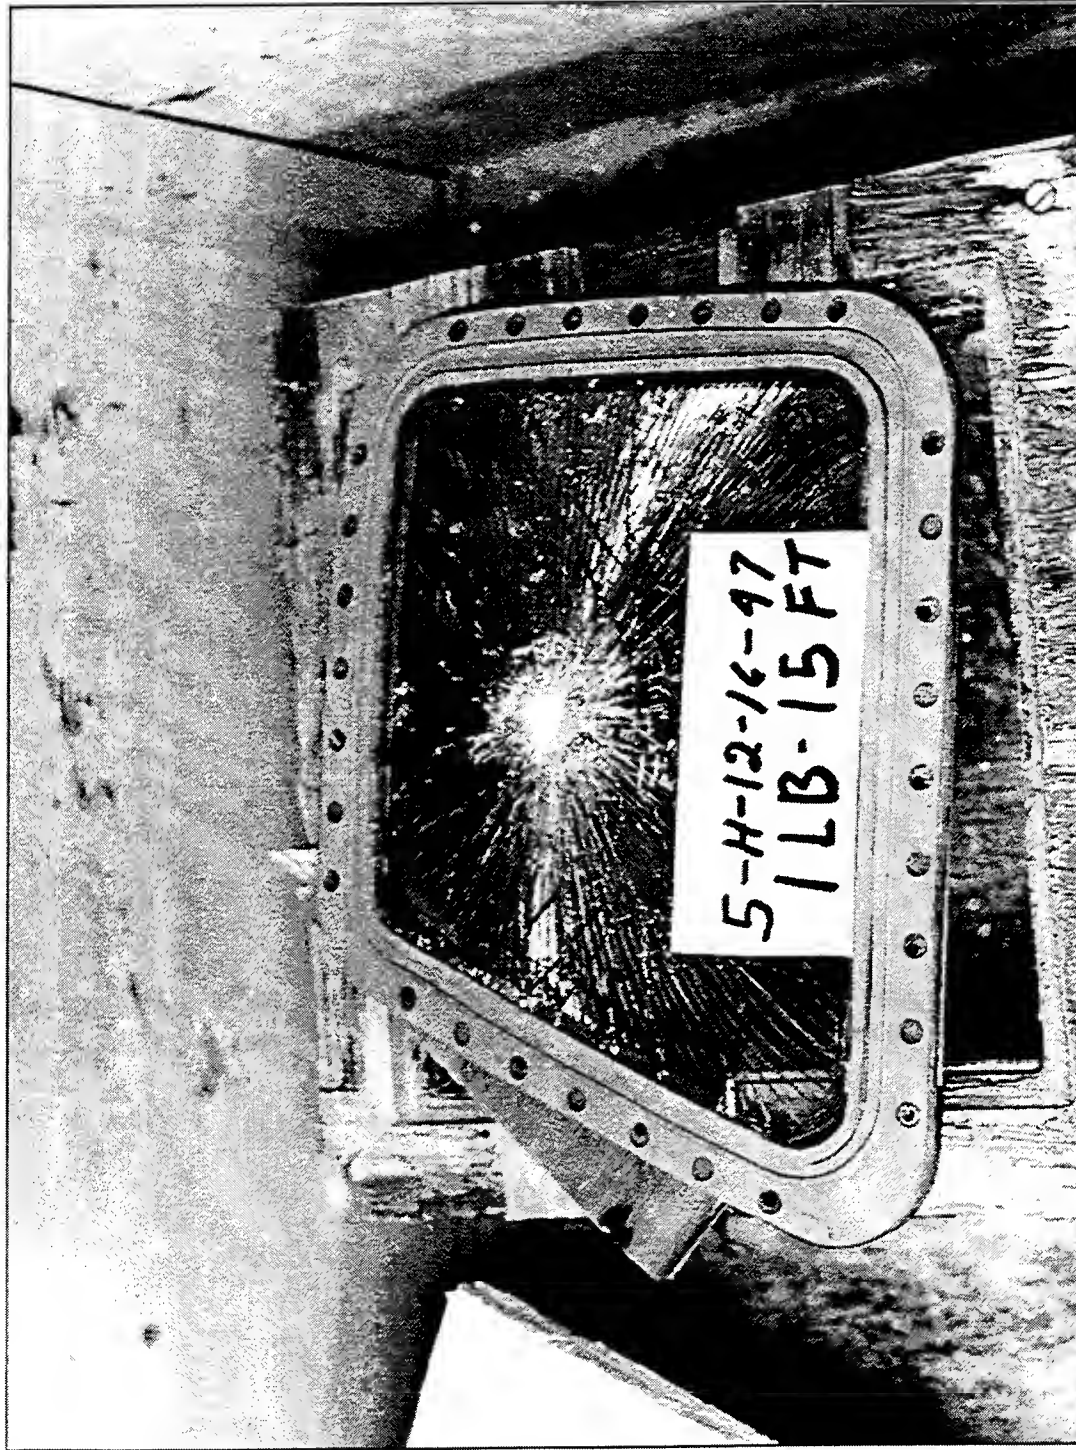
Figure 4.18 #4 W/WS Residual Strength Falling Ball Impact Test Result for a Repaired and Subsequently Delaminated W/WS, Outboard View
(S/N 5-H-12-16-47)

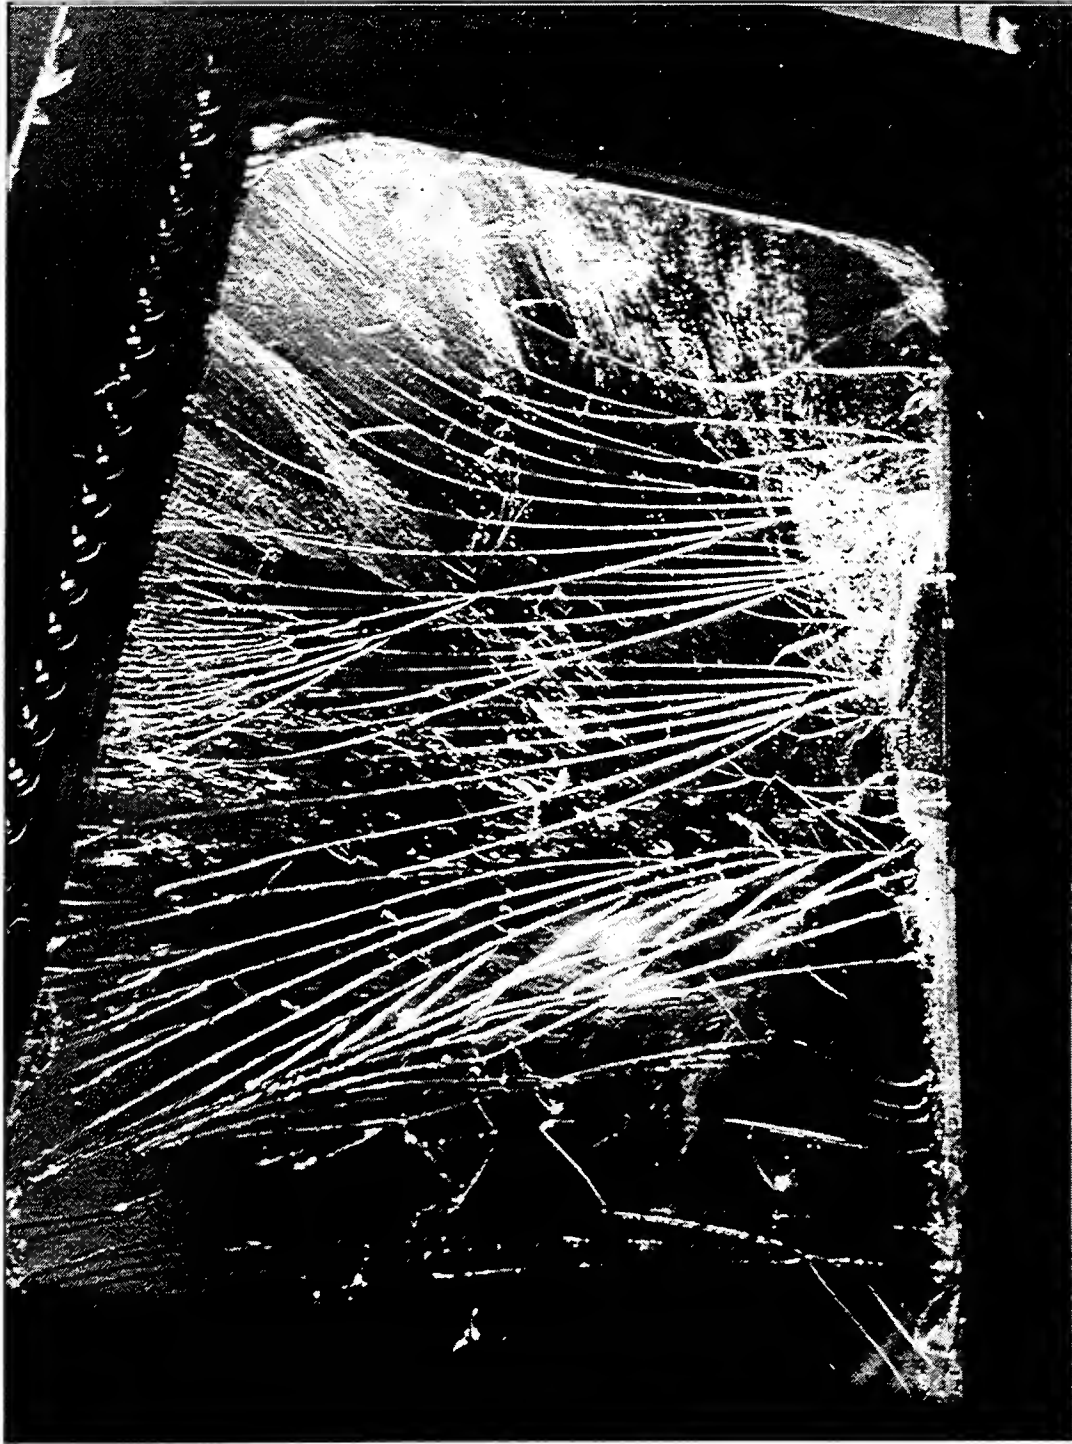
Figure 4.30 C/KC-135 #1 W/WS Showing Outboard Ply Failure From a 4-Pound Bird Impact at 251.7 Knots, Front View (New W/WS, S/N 86-H-10-06-007)
